Polyethylene Repair Products - CRP-PE

CRP-PE Repair Patch for high-temperature polyethylene coated pipelines

CRP-PE Repair Patch

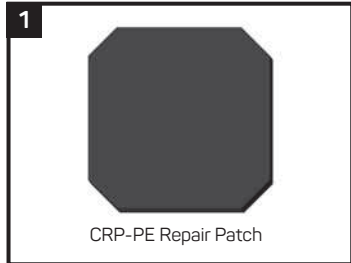
Pipeline Repair Patch

The Coating Repair Patch (CRP-PE) is supplied in 150mm x 150mm (6" by 6") patches or in rolls 150mm wide by 15m long, and can be field cut-to-size.

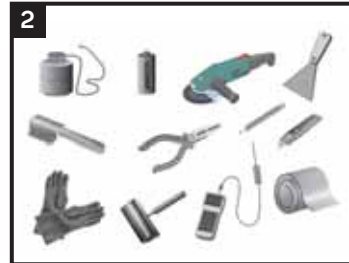
Equipment List

Propane tank, hose, torch & regulator; Appropriate tools for surface abrasion: grinder, 80-120 grit sandpaper; Appropriate tools for cleaning: rags & approved cleaner; Tools: roller, digital thermometer, knife, marker, measuring tape, scraper / spatula & pliers; Standard safety equipment; gloves, goggles, hard hat, etc.
